# Deepwater Horizon (Macondo) Blowout

A system-level examination  
of barriers, uncertainty,  
and escalation

Analysis based on U.S. Chemical Safety Board (CSB)  
Investigation Reports, Volume 2.

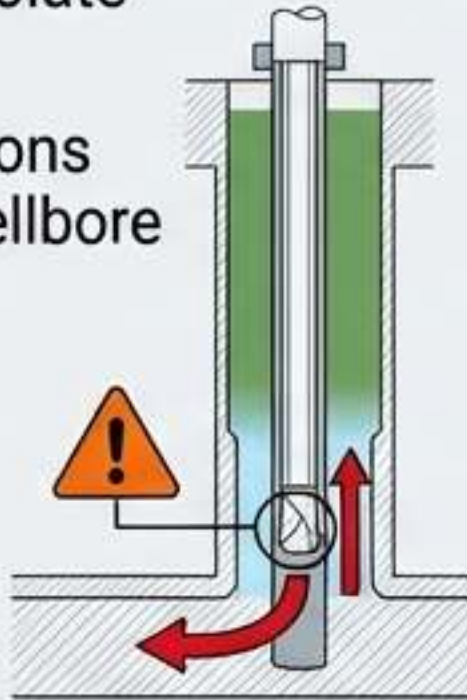
### Isolation Failure

- Bottom-hole cement failed to isolate reservoir.
- Hydrocarbons entered wellbore after mud removal.

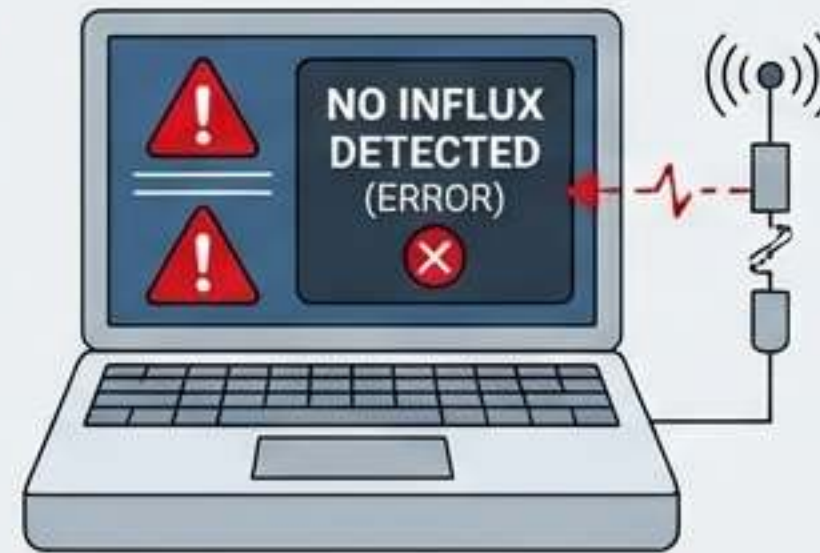
### Detection Failure

- Instrumentation and interpretation failed to identify influx.

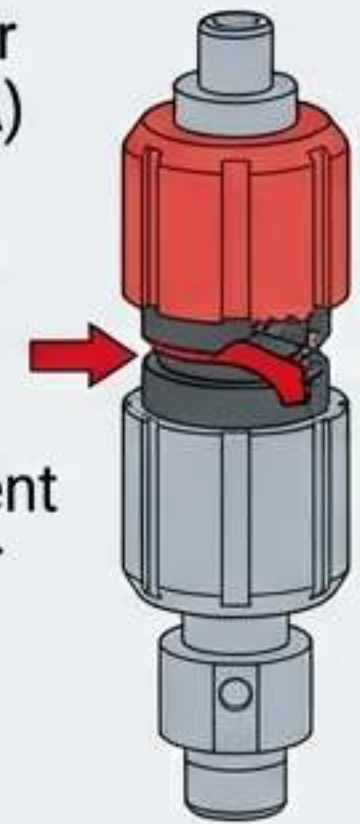
### Containment Failure

- Upper Annular Preventer (UA) activated ~9:43 PM but failed to seal.
- Likely cause: Rubber element erosion under high flow.

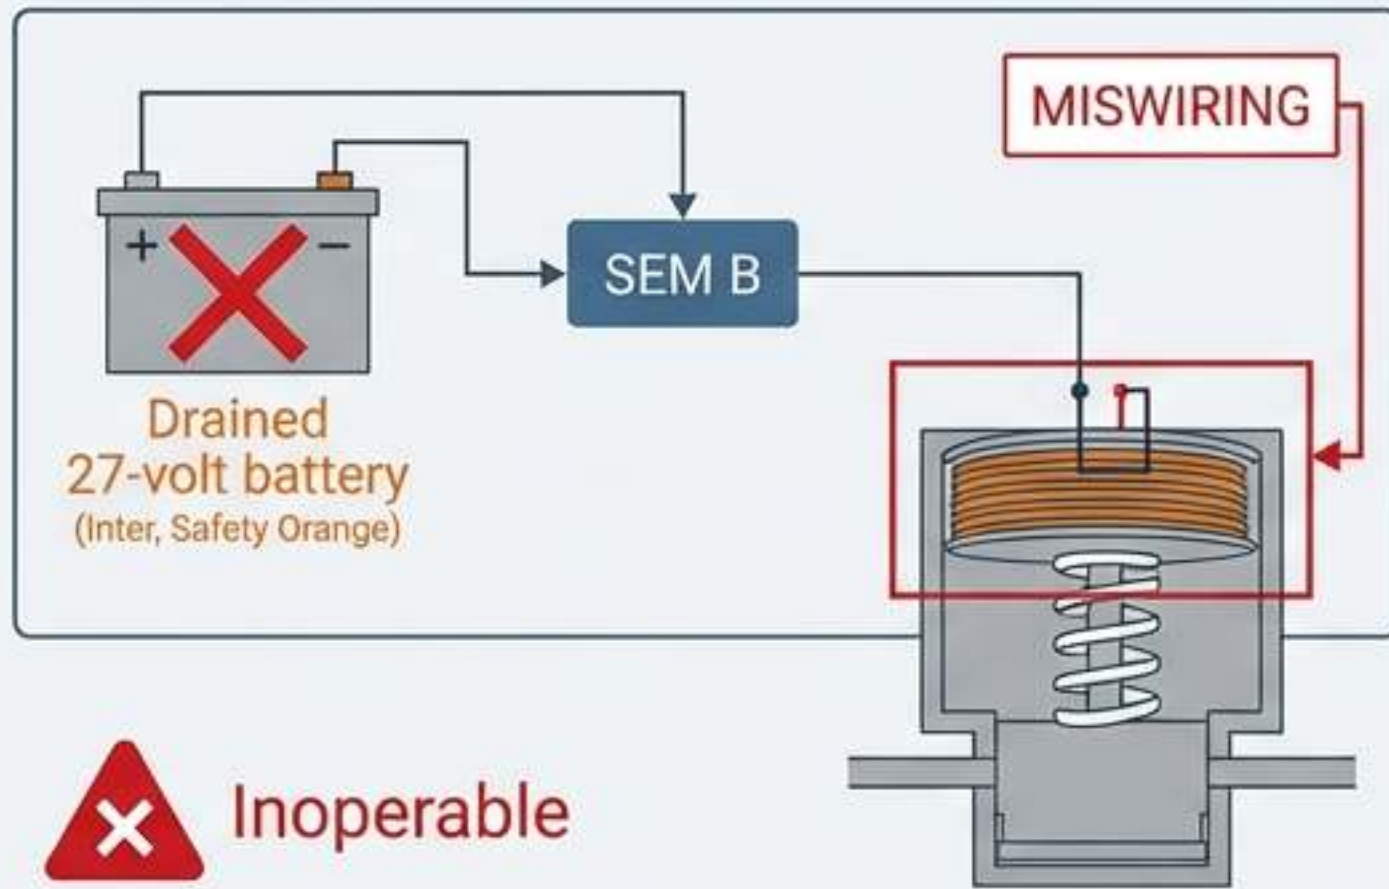
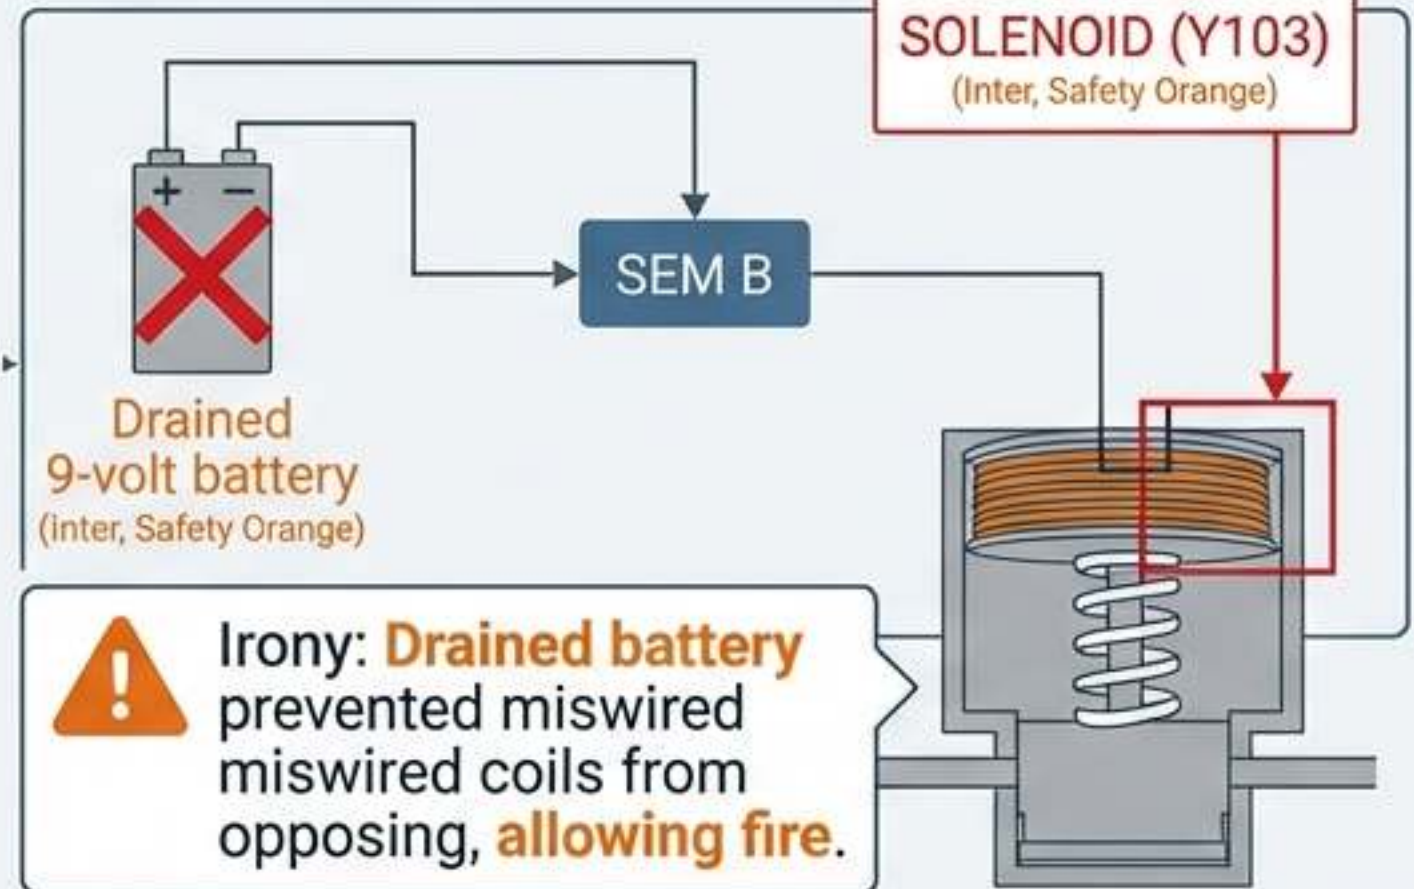
**COMMON MODE FAILURE:** Latent defects existed in **BOTH** emergency systems **simultaneously** due to inadequate testing.

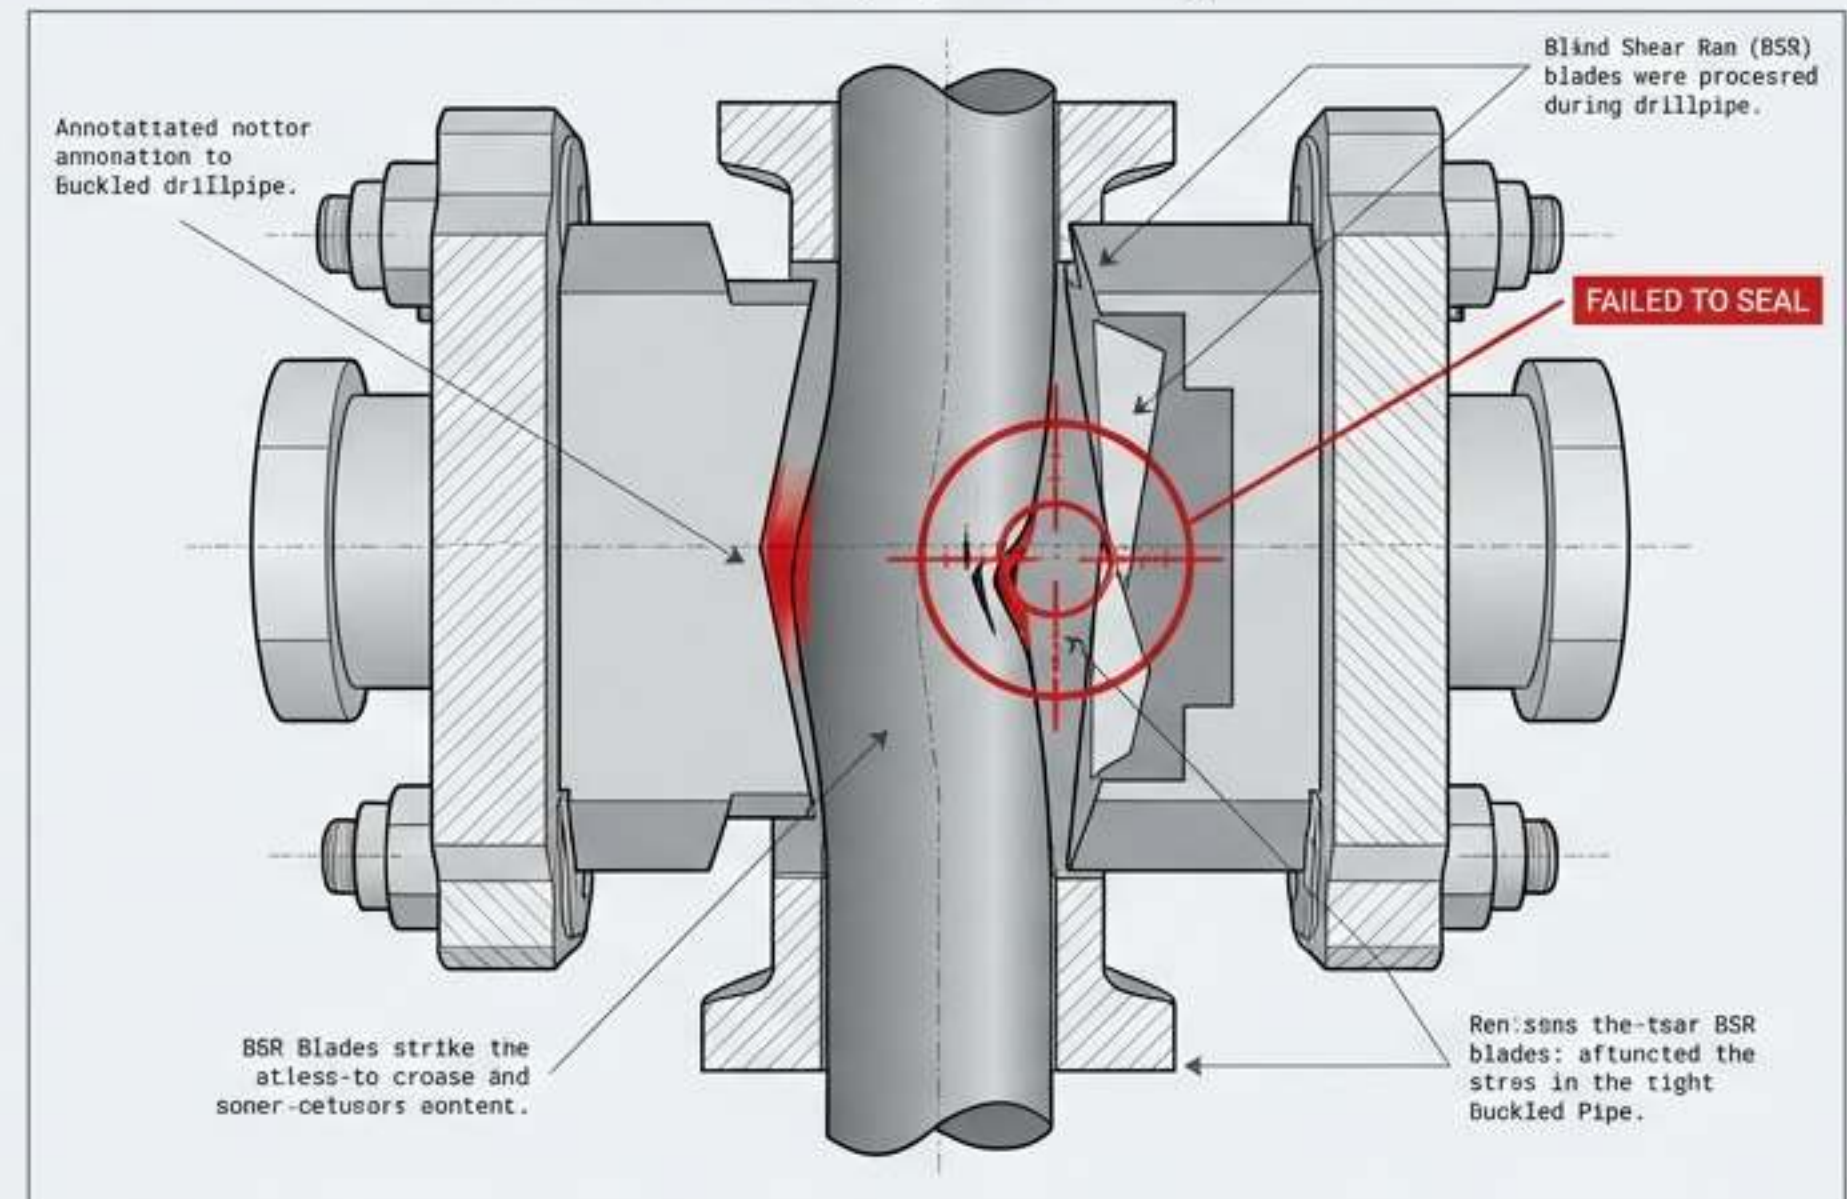
## Buckled Drillpipe Configuration

BSR activated but struck off-center, buckled pipe. Failed to seal.
