# Iberian Peninsula Blackout

A system-level examination of margin, interconnection, and cascading loss of stability

Date of Incident: April 28, 2025

Source: ICS Investigation Expert Panel Factual Report

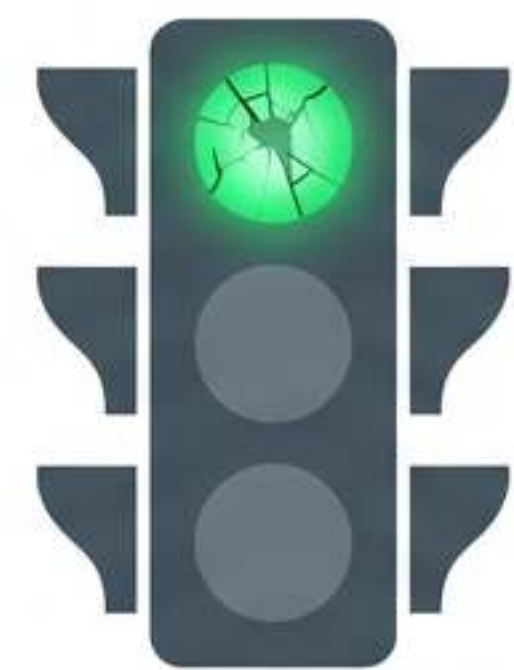
FIGURE 1: FRAGILE GREEN STATUS

| | Observation | Hidden Risk |
|---|---|---|
| Tooling Limitations | Observation<br>'N-1' Security Analysis showed Green. | Hidden Risk<br>Tools measured thermal congestion, not dynamic fragility. |
