# TESORO ANACORTES REFINERY INCIDENT

A system-level examination of equipment failure, operating context, and escalation

Investigation Analysis based on CSB Report (2014)

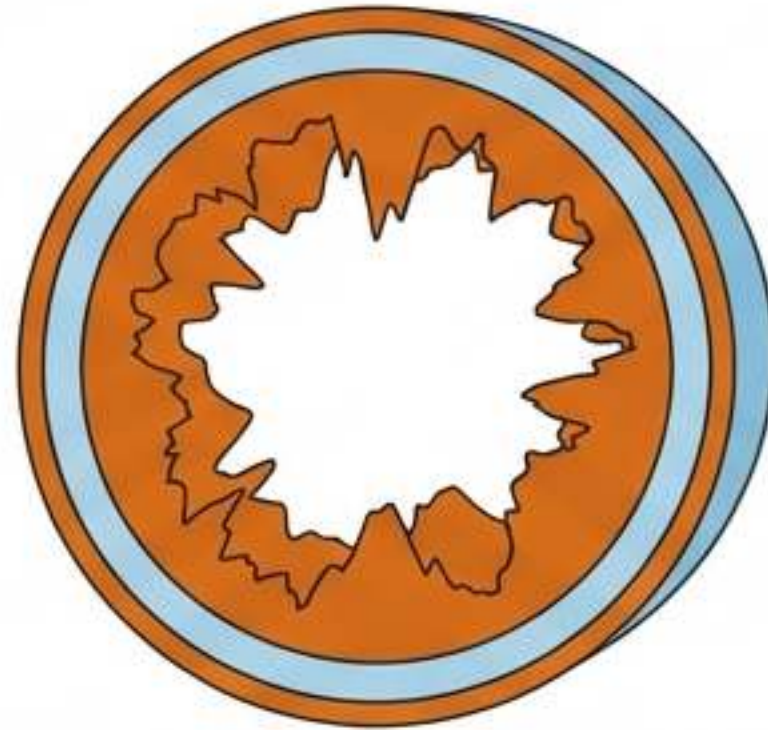
- **Fouling Conditions:** Internal deposits inhibited heat transfer, requiring higher temperatures to maintain efficiency.
- **The “Clean-and-Switch” Routine:** Periodic cleaning required one bank (e.g., A/B/C) to be taken offline while D/E/F remained online.
- **Stressed State:** Startup was a non-routine, transient operation involving thermal cycling.

Operating State: Fouled Tube
