# Deepwater Horizon (Macondo) Blowout

A system-level examination  
of barriers, uncertainty,  
and escalation

Analysis based on U.S. Chemical Safety Board (CSB)  
Investigation Reports, Volume 2.

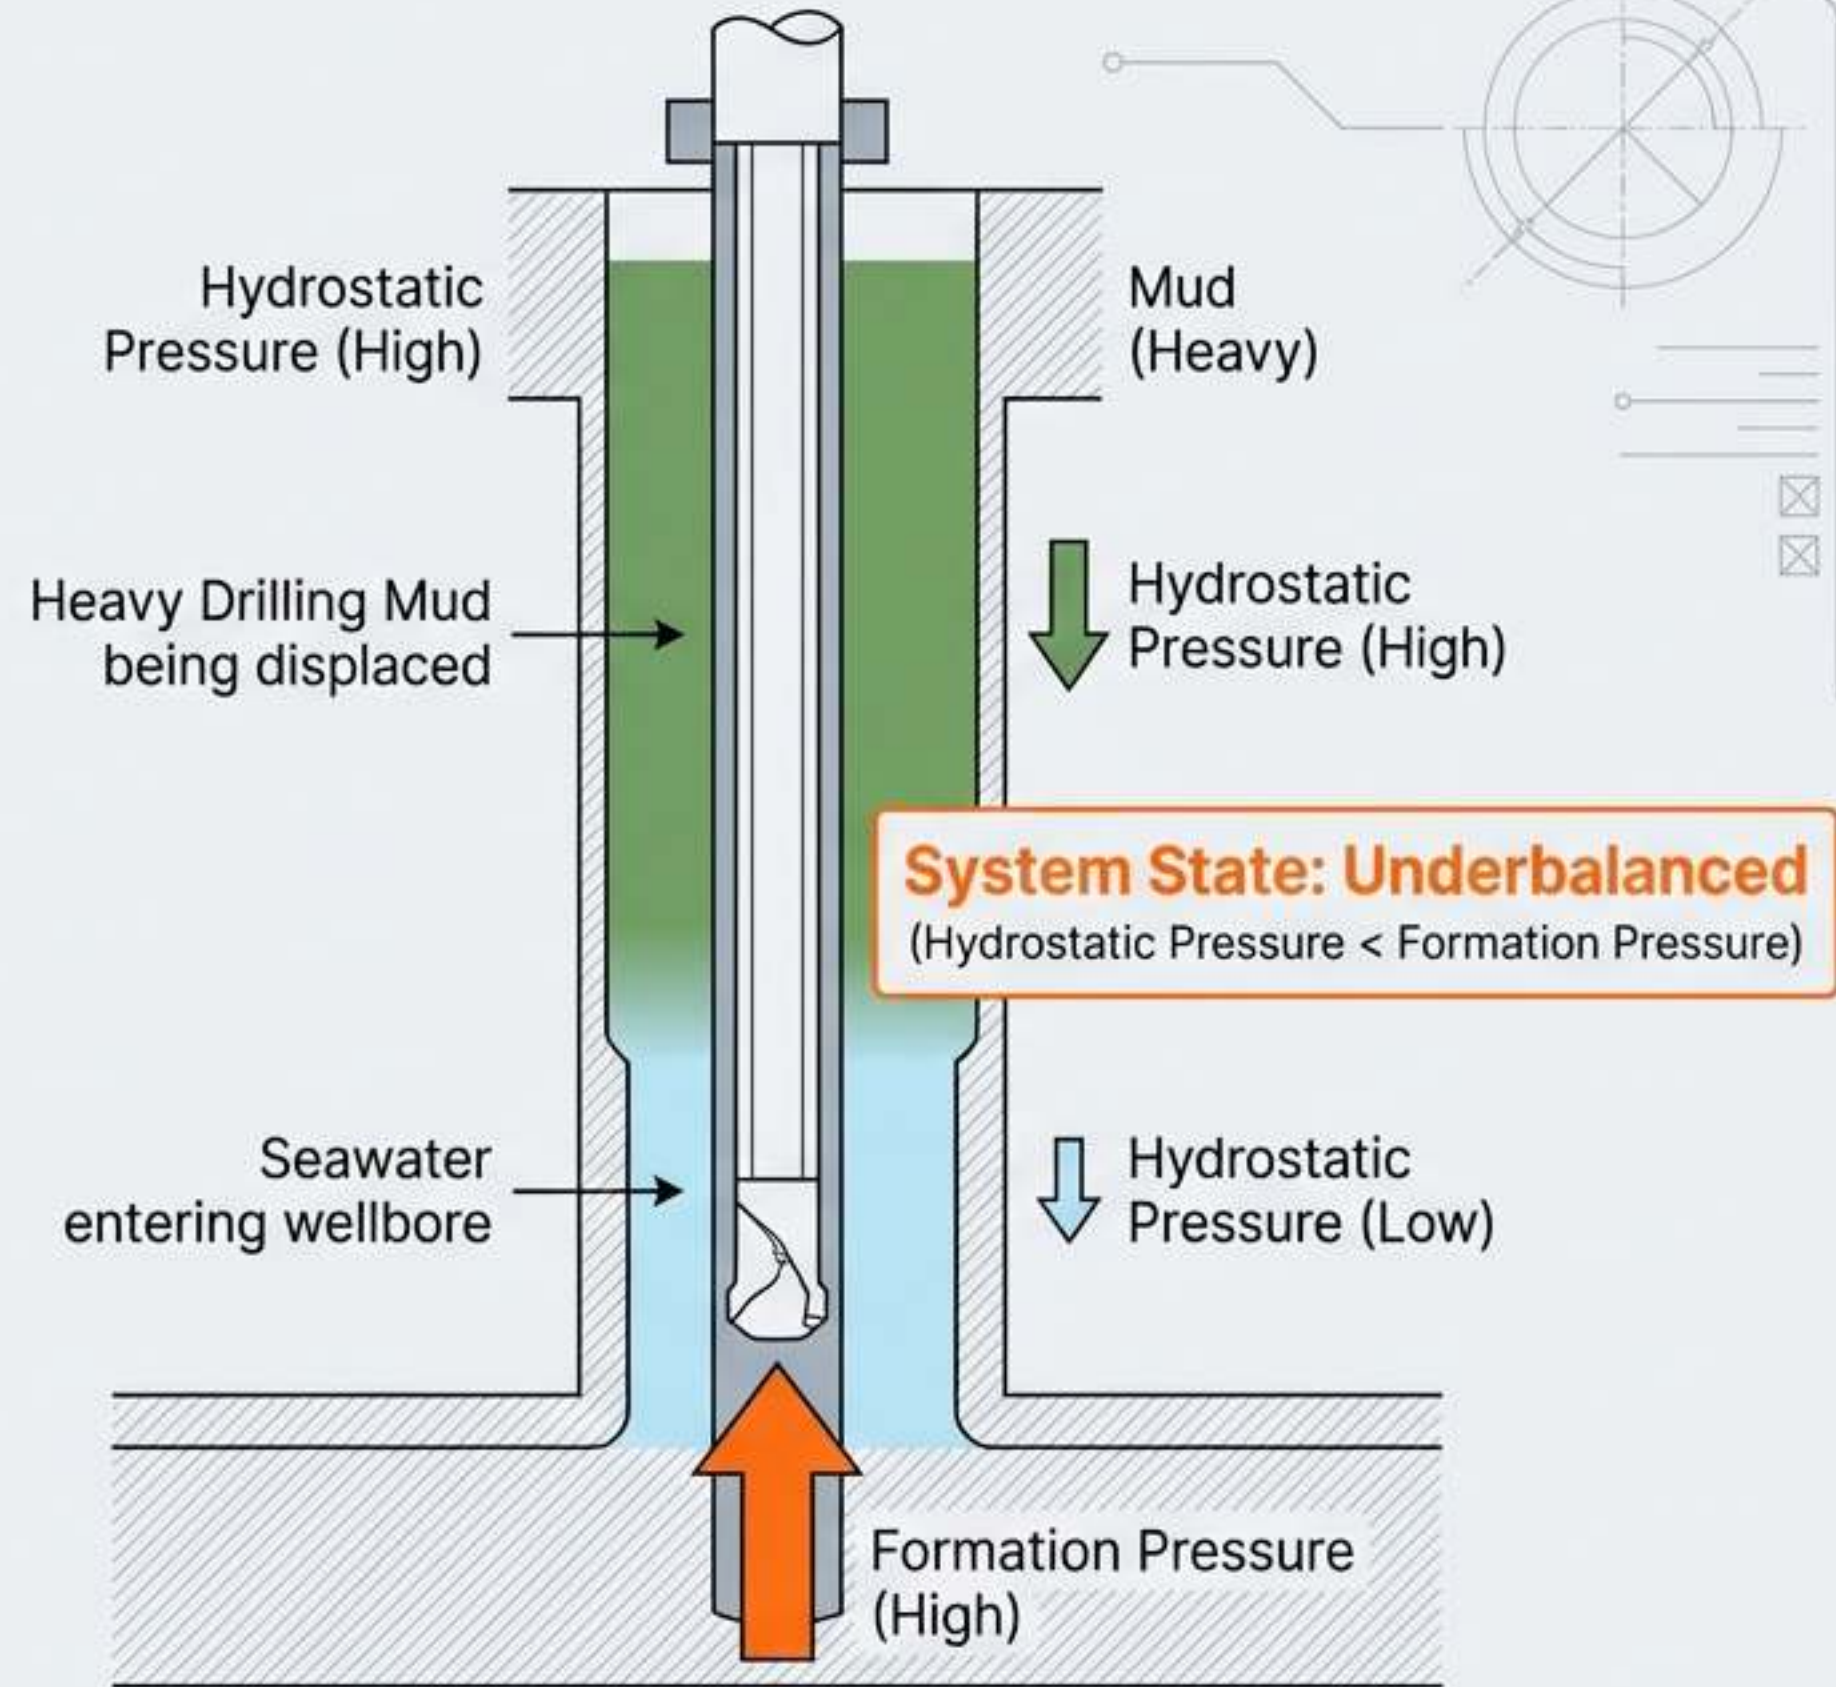
- **Activity:** Displacement of heavy mud with seawater.
- **System State:** Underbalanced (Hydrostatic pressure < Formation pressure).
- **Verification:** Reliance on “negative pressure test” interpretation.
- **Constraints:** Time and cost pressures; multiple concurrent activities.

- **The Decision Gap: Safety depended entirely on human interpretation of equivocal pressure data.**
